USAAVLABS TECHNICAL REPORT 65-68

GROUND AND FLIGHT TESTS,  
XV-9A HOT CYCLE RESEARCH AIRCRAFT

C. W. Pieper

SUMMARY REPORT  
HTC-AD 65-13

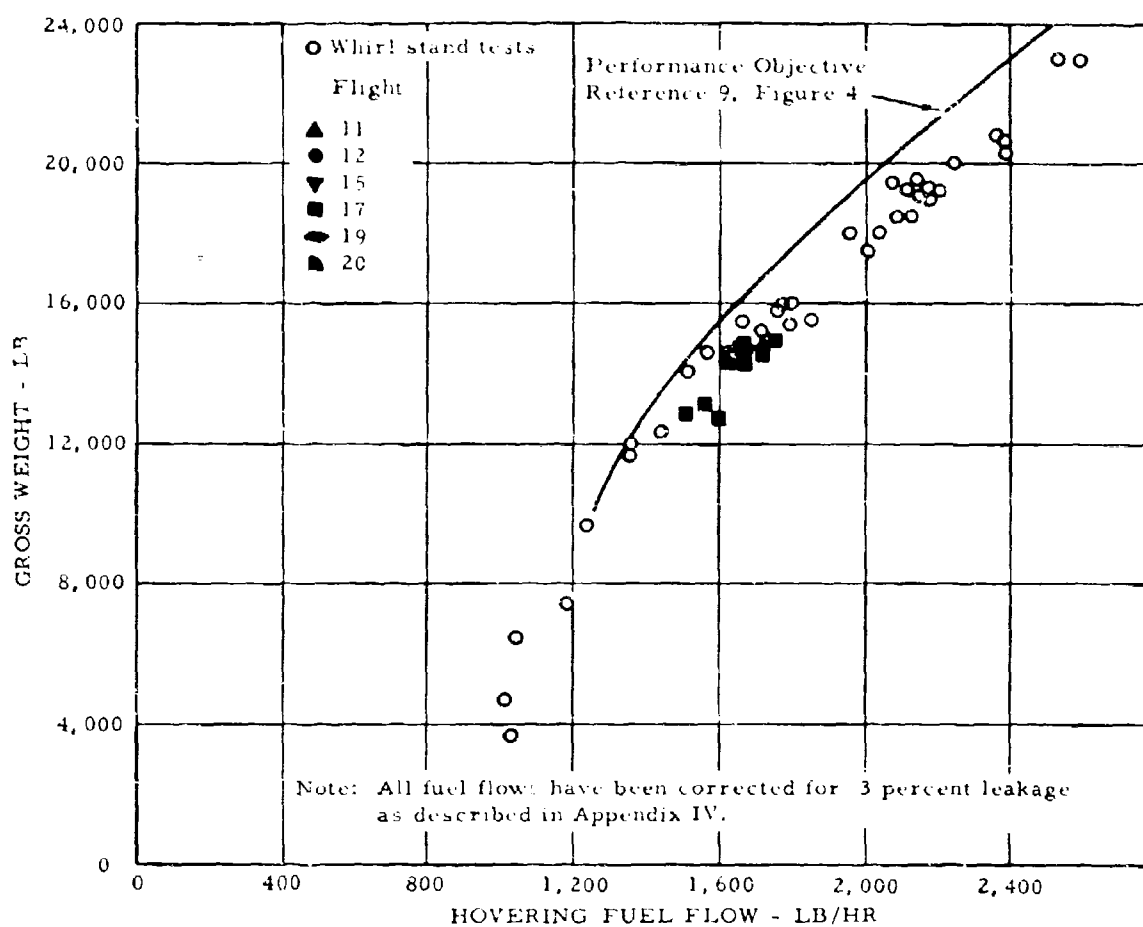
Figure 19. Hovering Fuel Flow Versus Gross Weight.

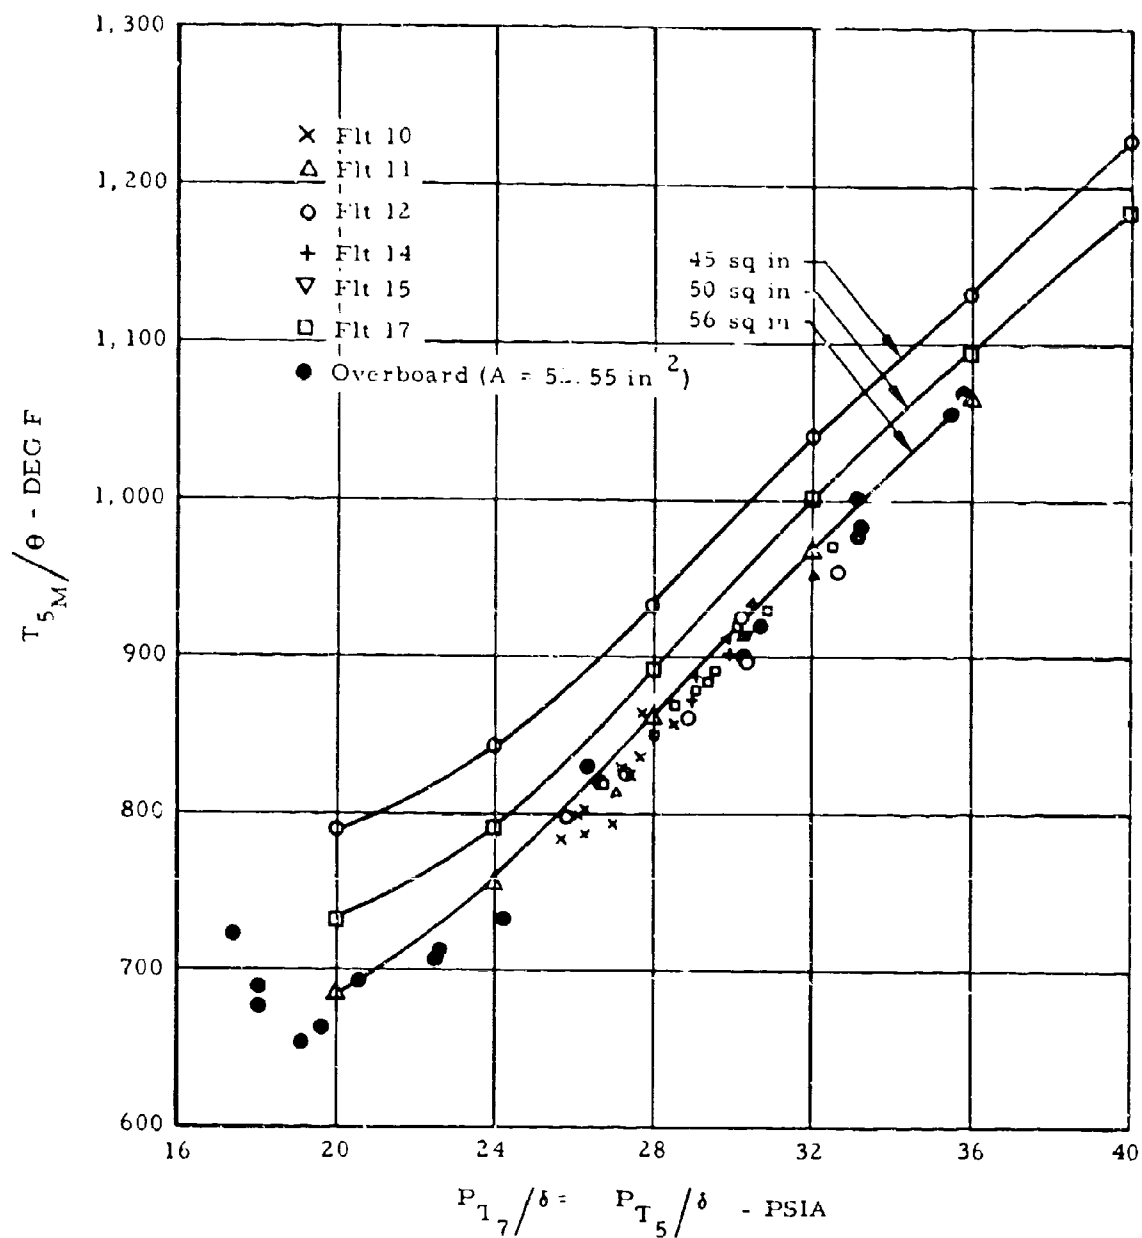
Figure 20.  $T_5$  Versus  $T_5$  and  $P_7$  Correlation, Engine 027-1A.

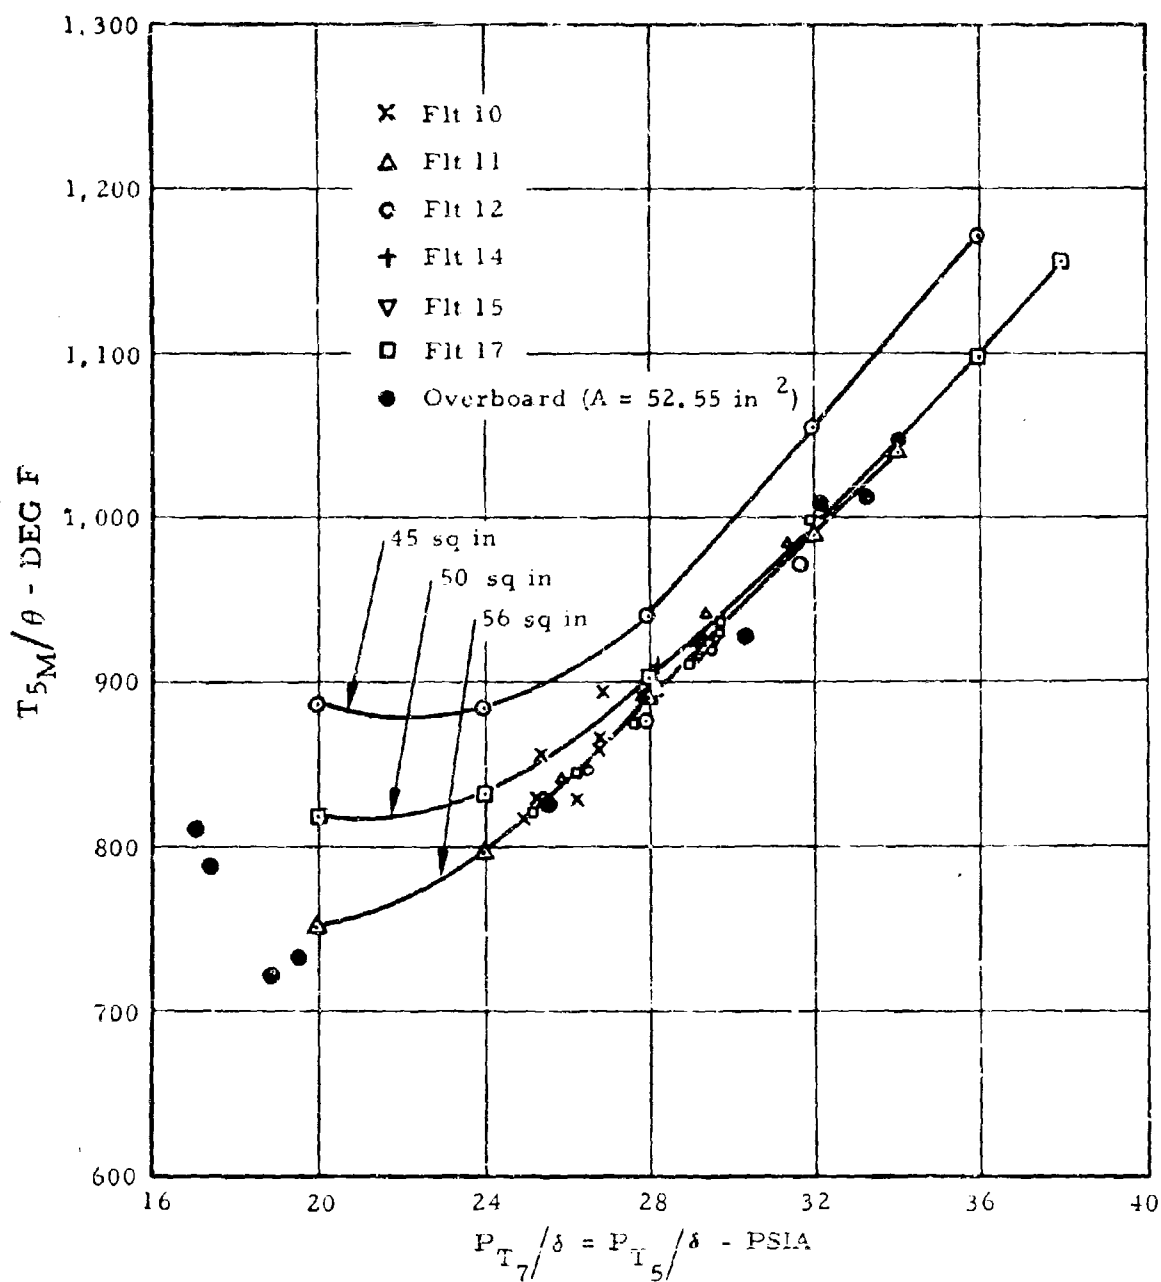
Figure 21.  $T_5$  Versus  $P_5$  and  $P_7$  Correlation, Engine 026-1B.

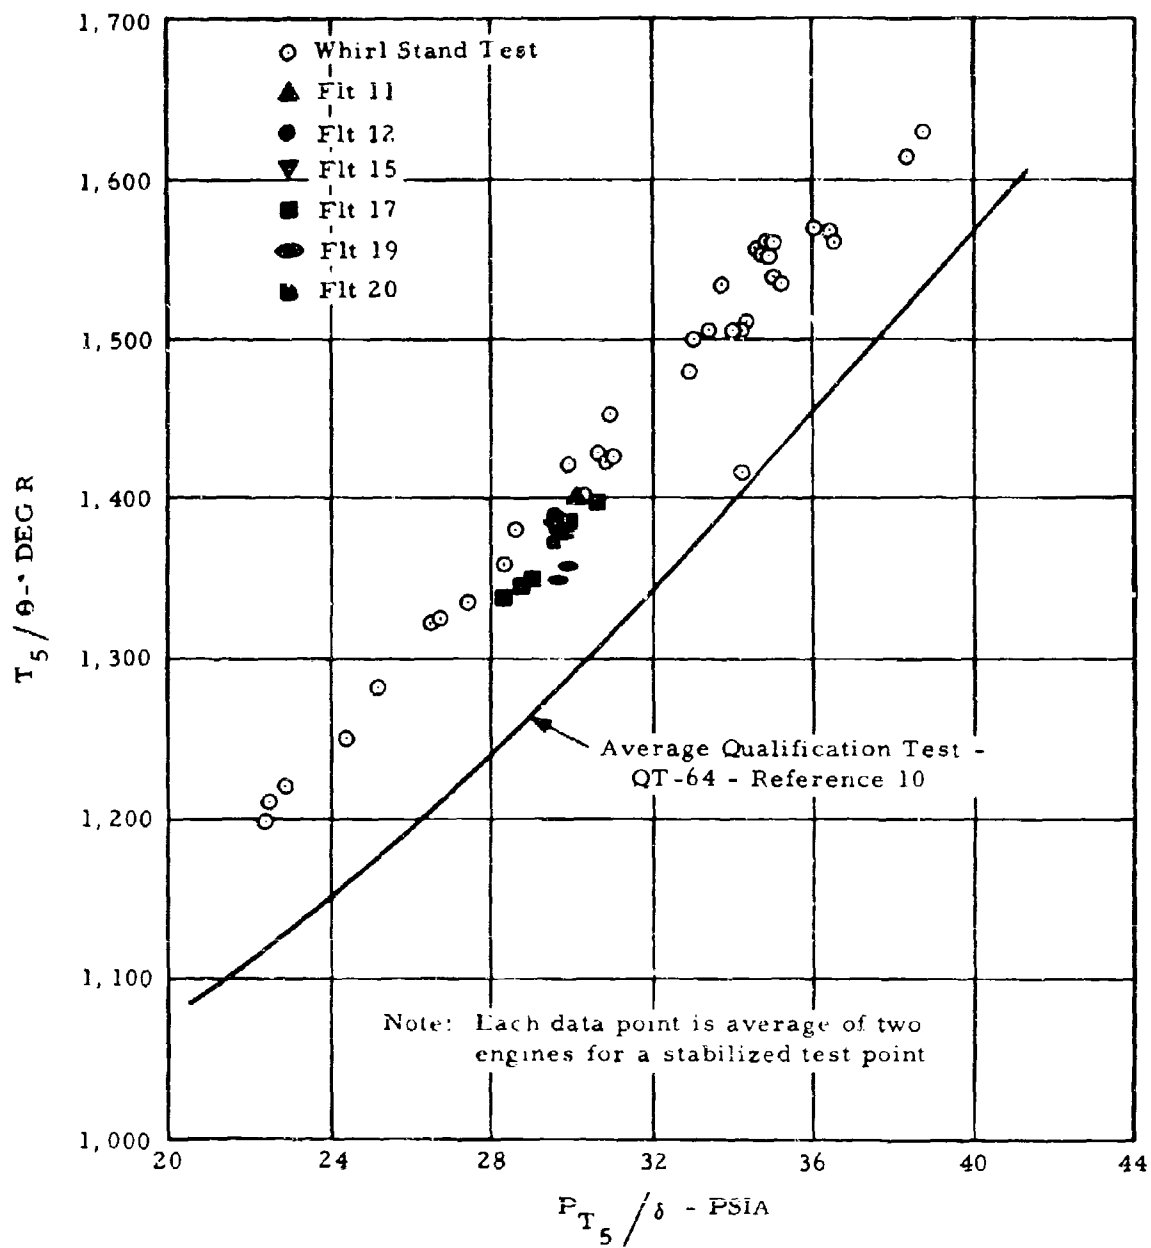
Figure 22. Engine Discharge Temperature Versus Pressure.

T-64 engine. This comparison is made in Figure 22, with  $T_5$ 's and  $P_5$ 's averaged for two engines at each test point. The consistency of both whirl and flight results is encouraging.

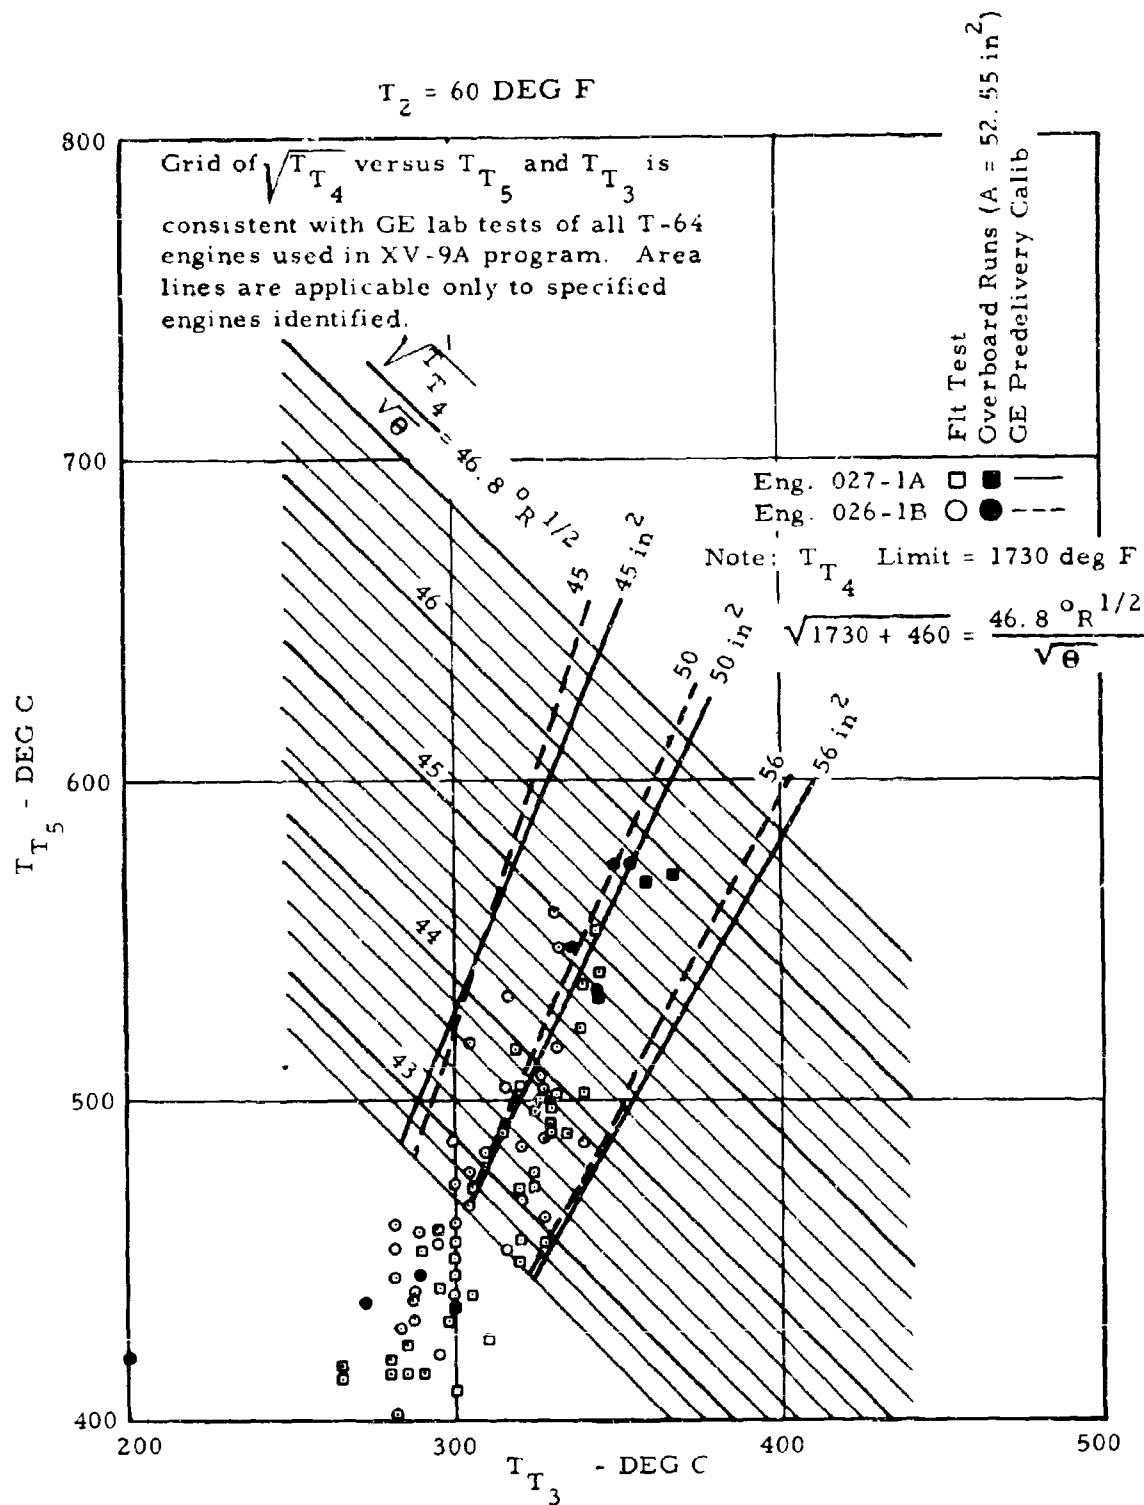
Figure 23. Engine Temperature Relationships.

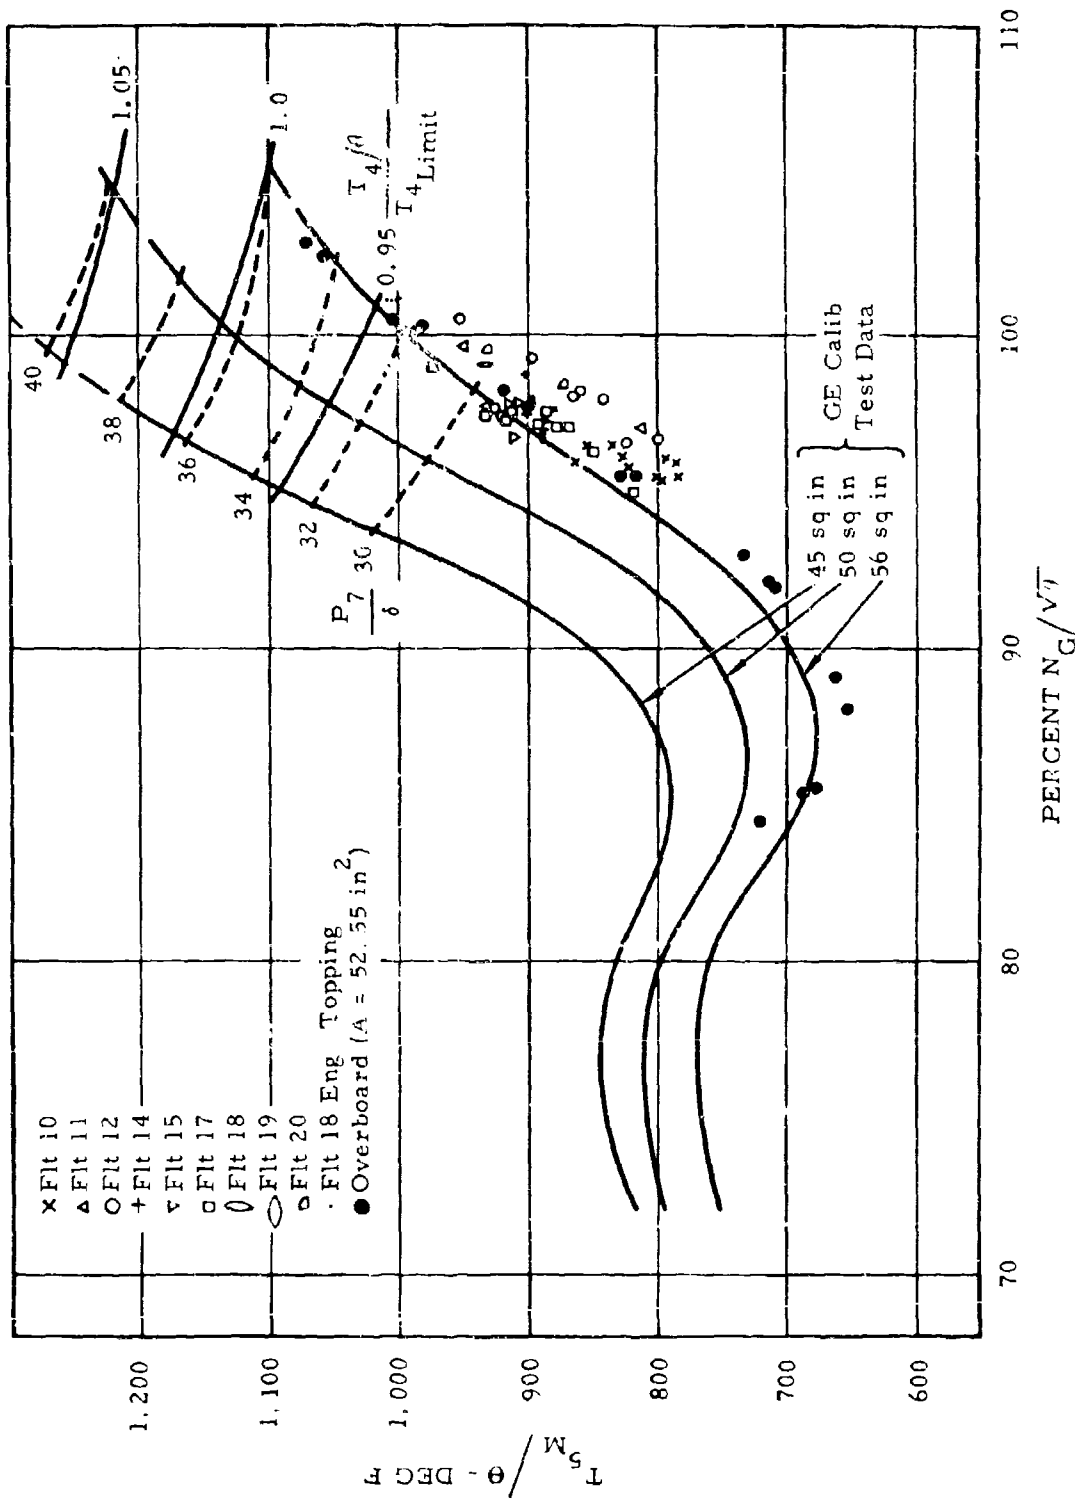
Figure 24. T-64 Engine 027-1A Operating Data.

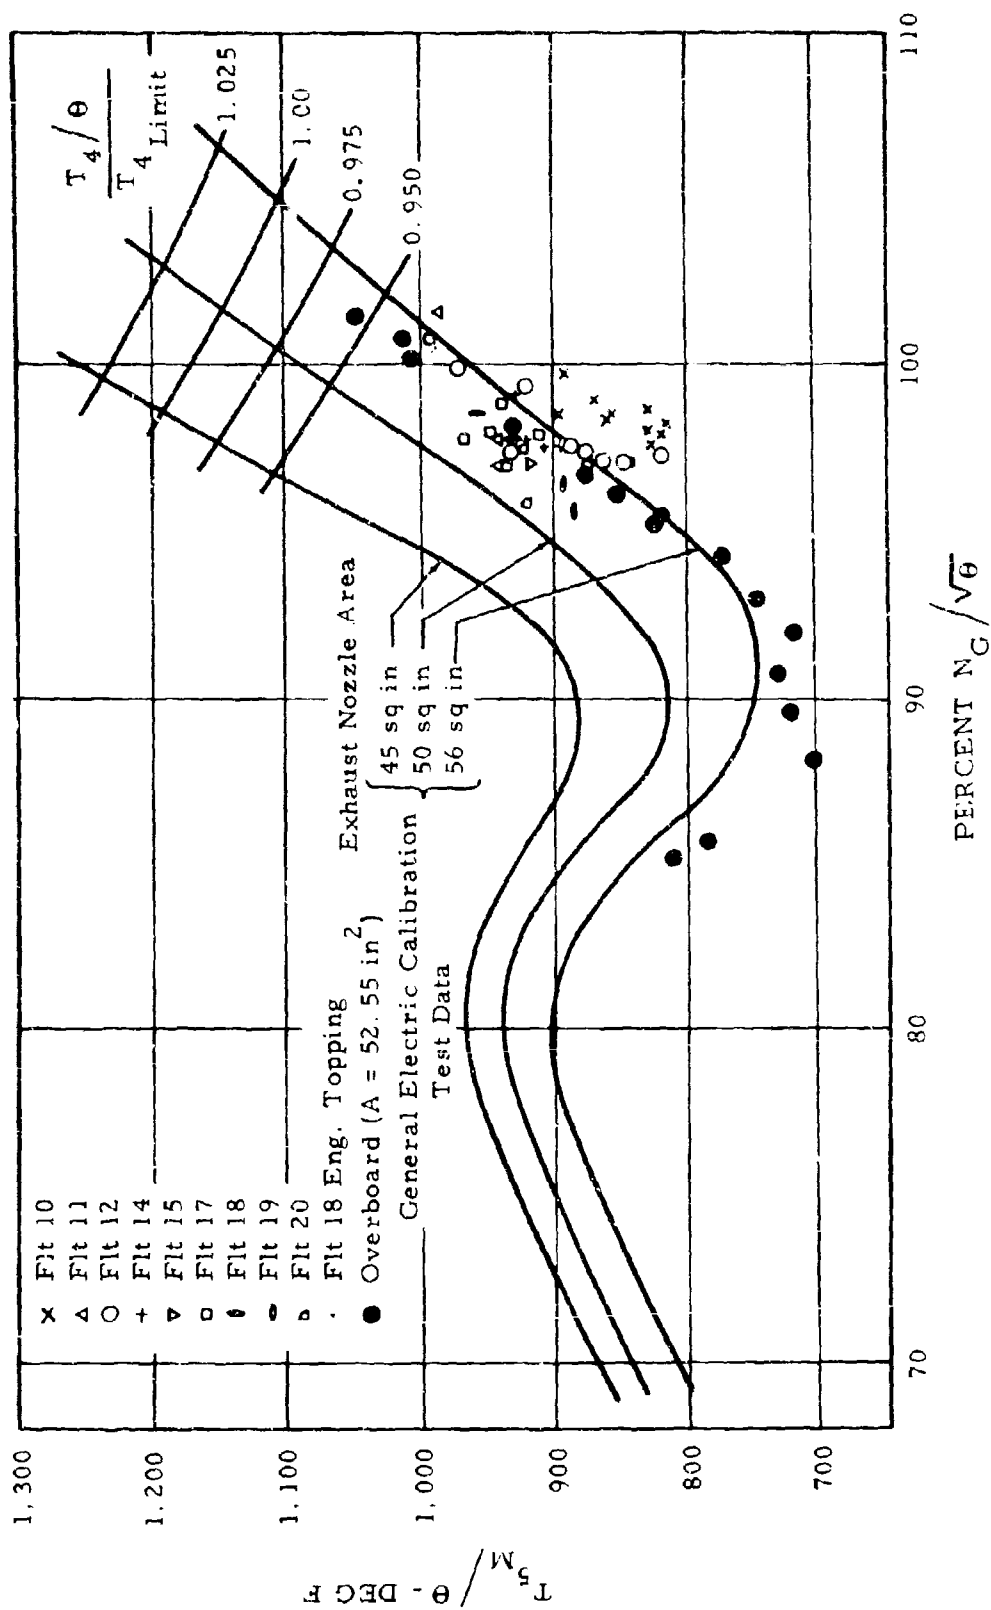
Figure 25. T-64 Engine 026-1B Operating Data.

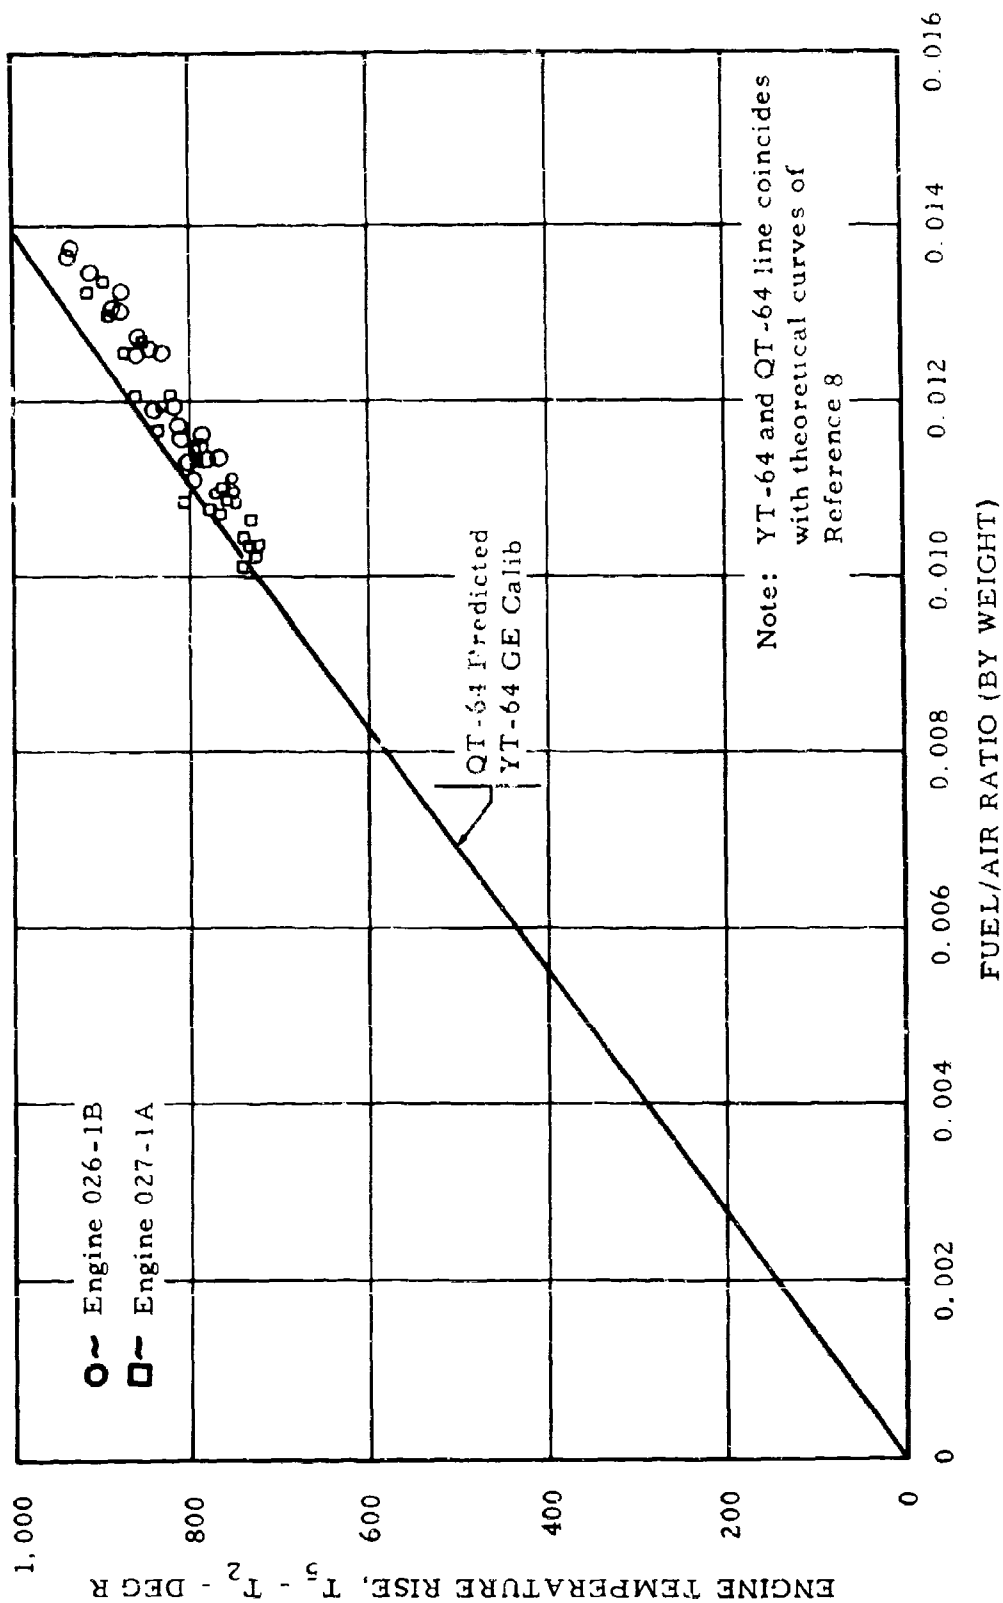
Figure 26. Temperature Rise Versus Fuel Air Ratio.

A final viewpoint on engine performance is offered in Figure 26. Here, engine fuel/air ratio is plotted against measured engine temperature rise. The solid line represents General Electric's prediction for the T-64 engine as well as their predelivery calibration of the YT-64's used in the XV-9A. This line is also consistent with the theoretical heating value of typical jet fuel, Reference 8. The flight points for both engines are remarkably consistent -- speaking well for all the temperature and flow rate measurements that are involved. The offset of the flight test fuel/air ratios to higher values for a given temperature rise is believed to be due to compressor bleed flow used to drive the oil cooler aspirator. As pointed out in Appendix IV, the correction of hovering fuel flow for compressor bleed, Figure 19, amounts to moving the fuel/air ratio points from their observed location to the General Electric calibration line. Shaft power extraction for hydraulic pump and generator drive also contributes to the increase in fuel/air ratio, but the magnitude of this effect would be less than 1/4 of 1 percent for the 6 to 7 horsepower extracted per engine during the flight tests.

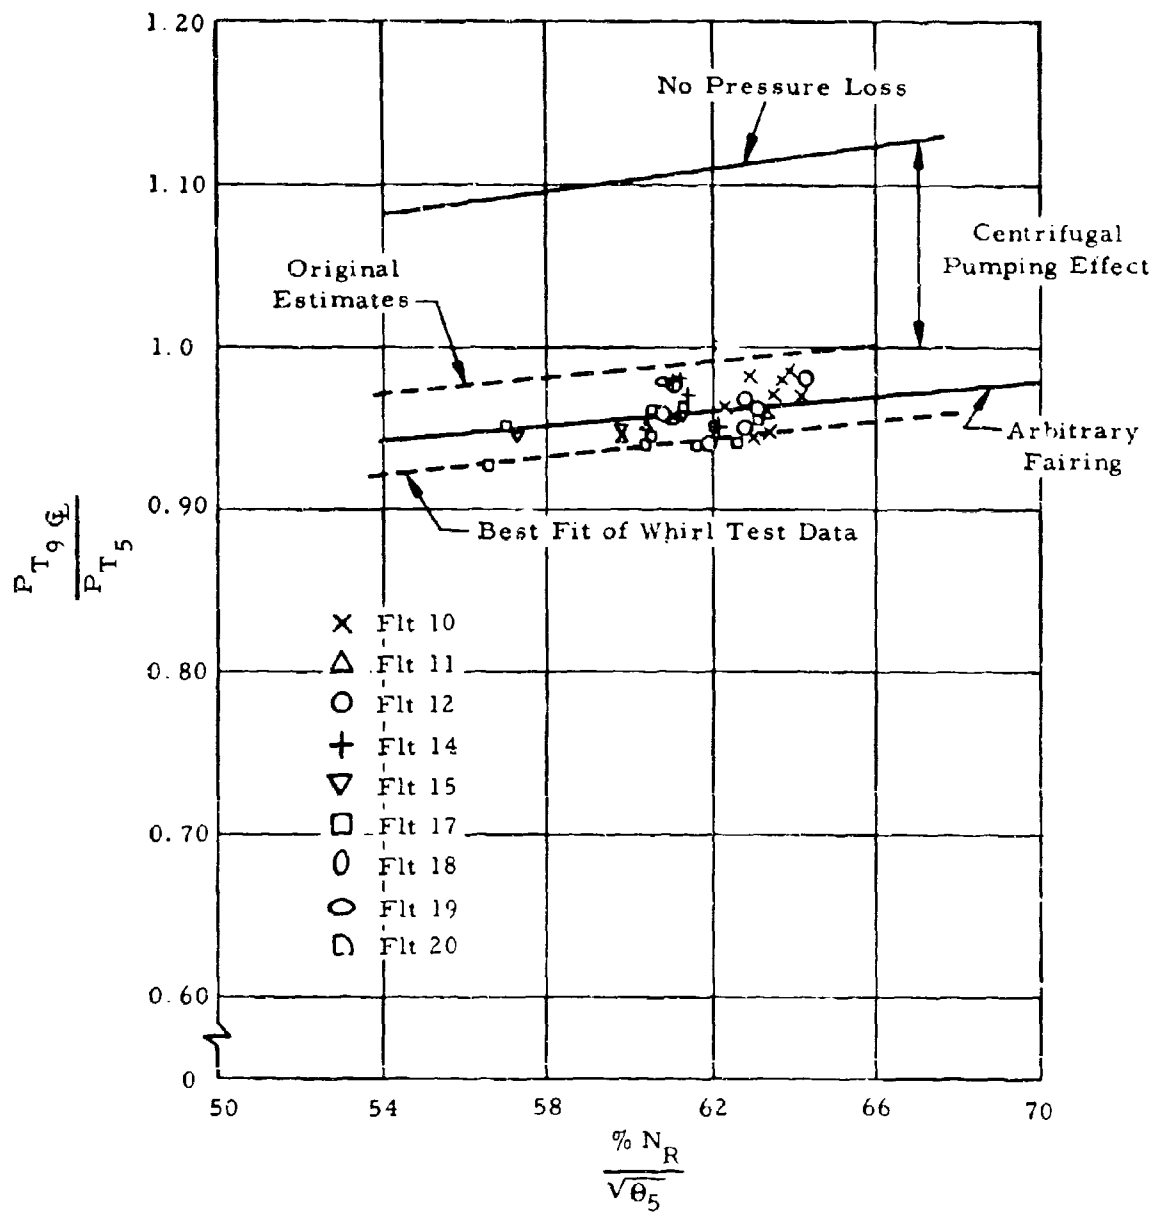
Figure 28. Rotor System Pressure Ratio.

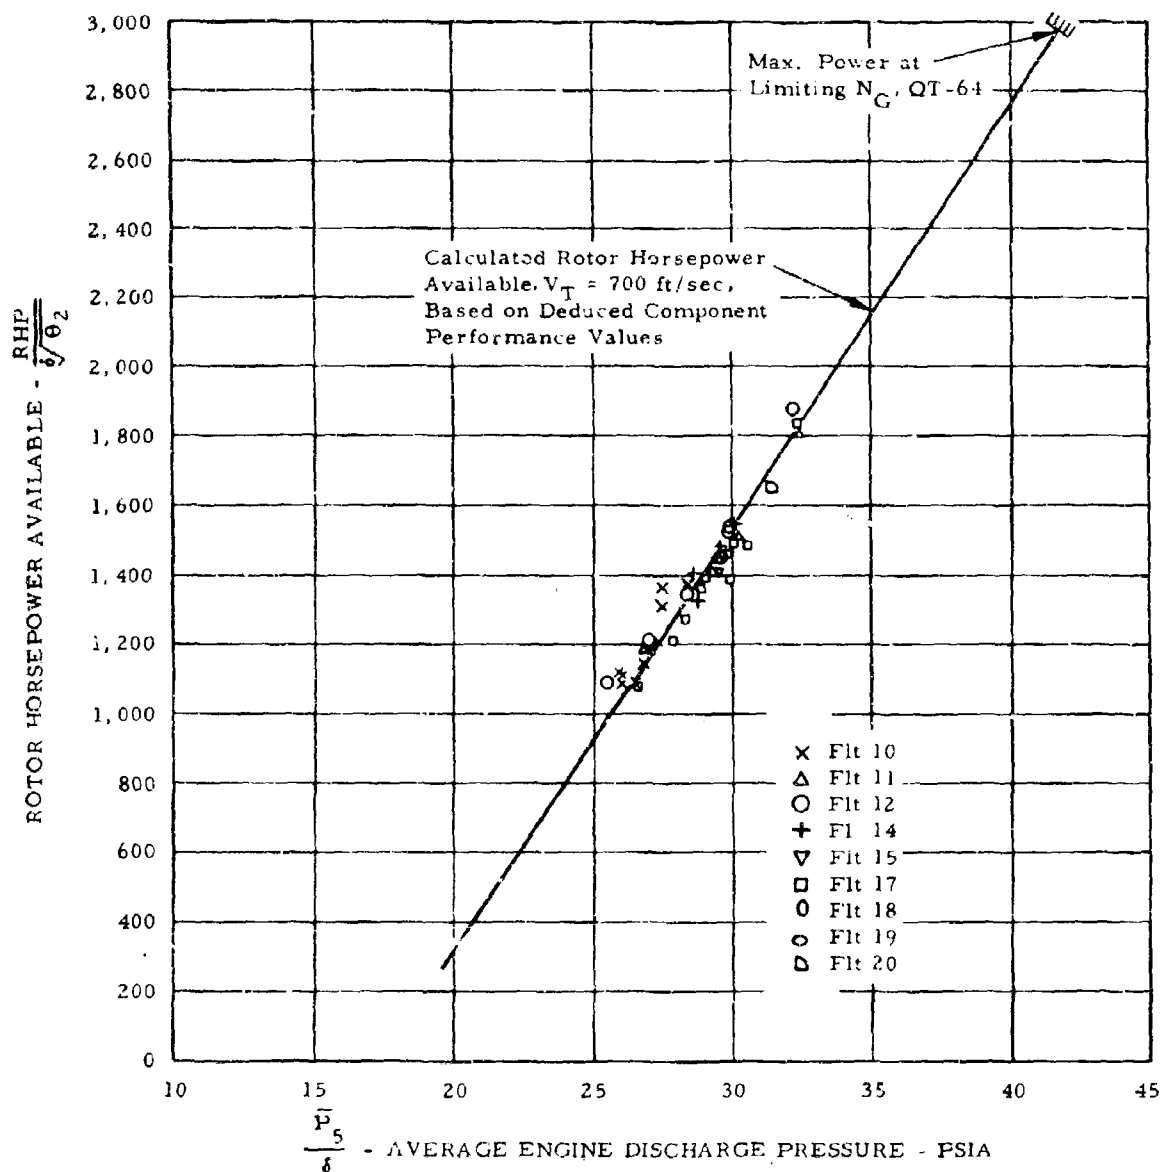
Figure 29. Rotor Horsepower Available Versus  $\bar{P}_5$  (Average Engine Discharge Pressure).

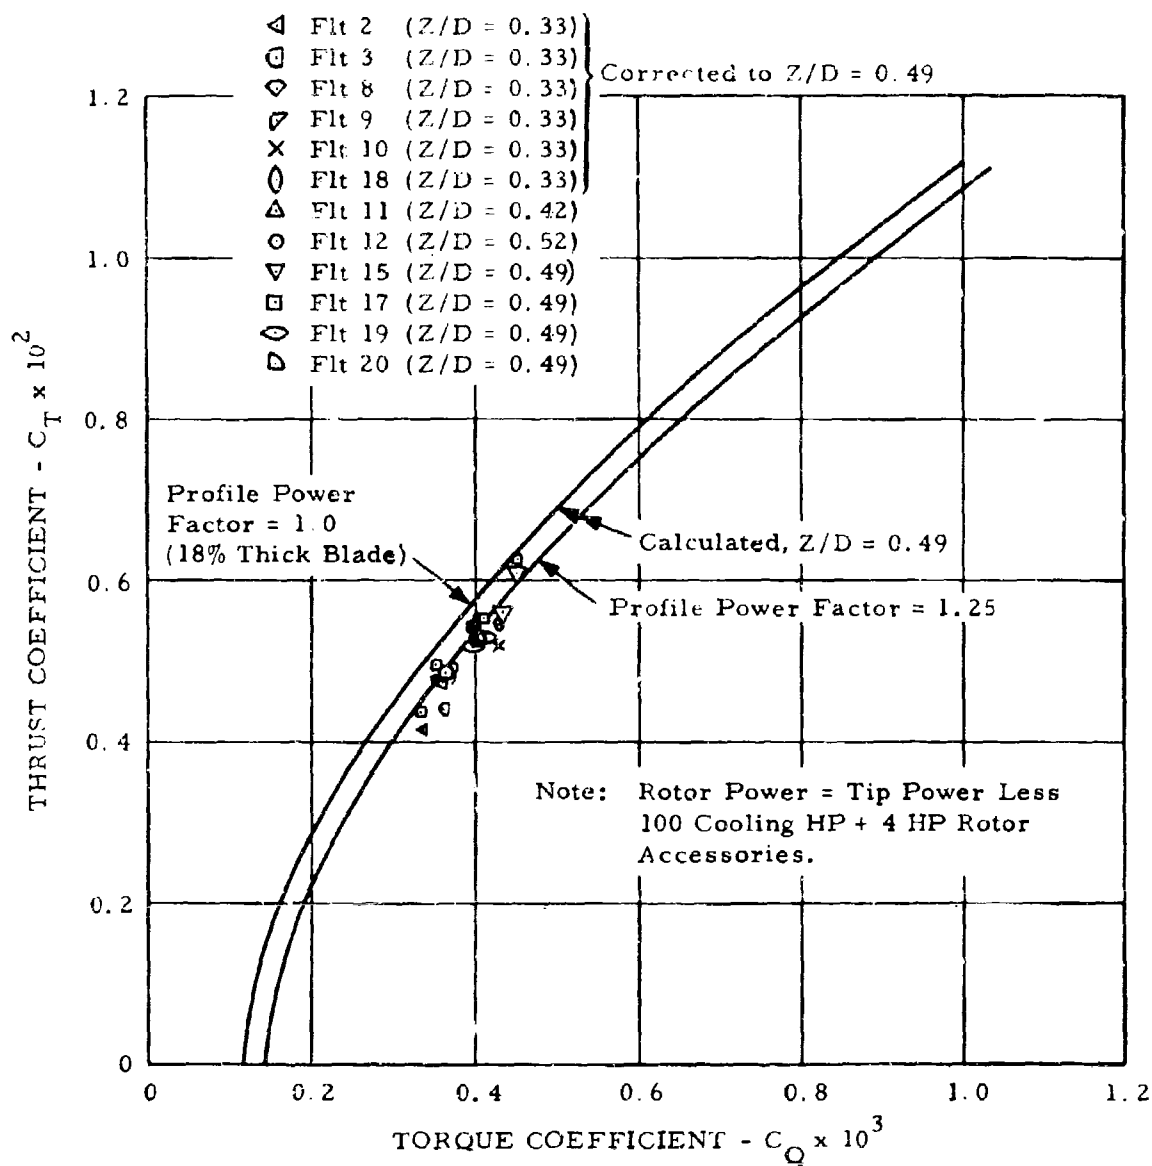
Figure 30. Hover Performance Thrust Coefficient Versus Torque Coefficient.

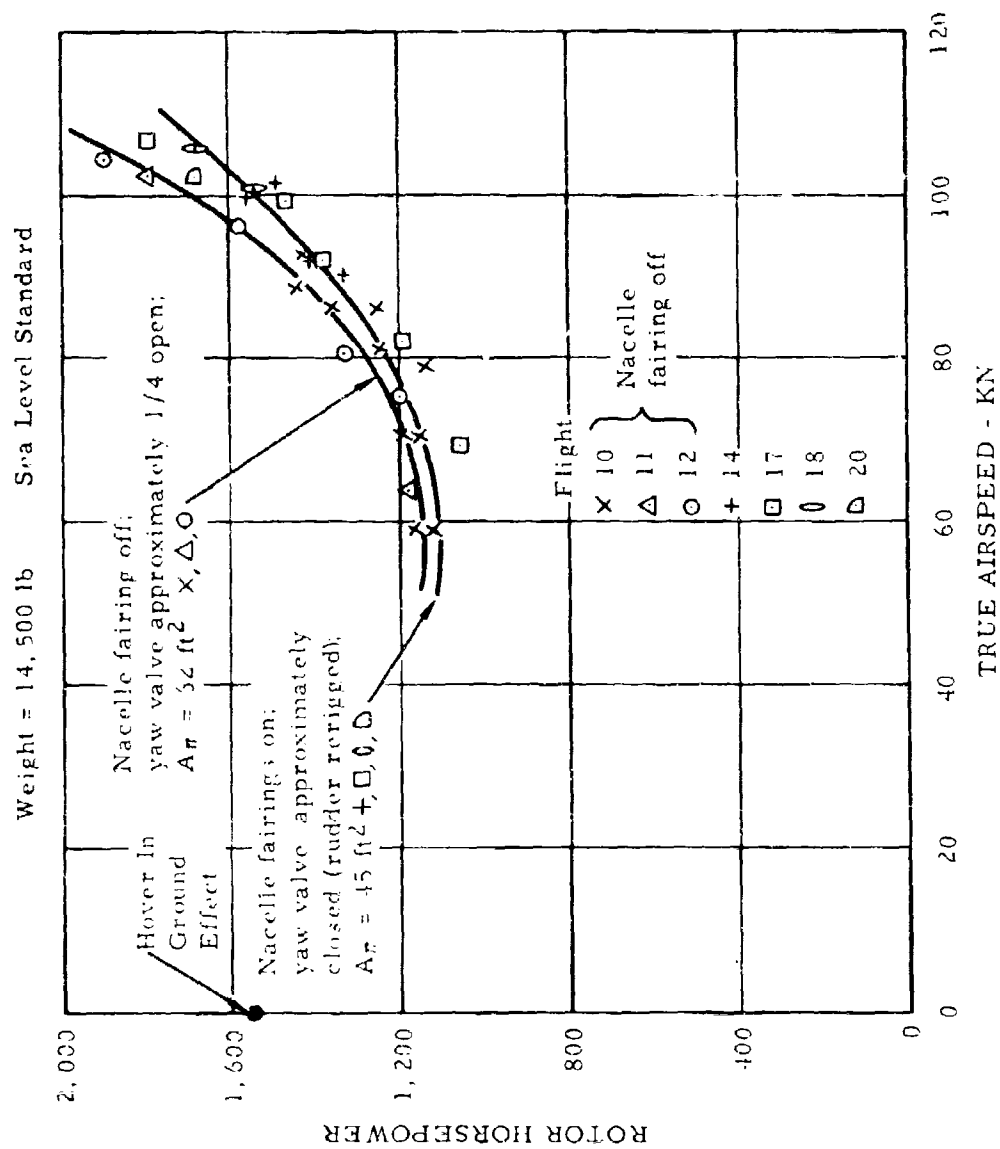
Figure 31. Power Required (Weight = 14,500 Pounds, Sea Level Standard).

to observe the helicopter parasite drag area. Those calculations that best fair the various sets of flight data are reproduced in Figure 31 along with the test points. Data handled in this fashion indicated that the parasite drag area,  $A_p$ , of the helicopter for early flights (up to flight 13) was approximately 62 square feet. During these flights, nacelle fairings were not yet installed and the yaw valve was apparently open approximately 25 percent. The flow coefficient of the yaw valve was not known, but, to be conservative, the entire engine airflow (less 3-percent leakage of the diverter valves) was assumed to go to the rotor tips.

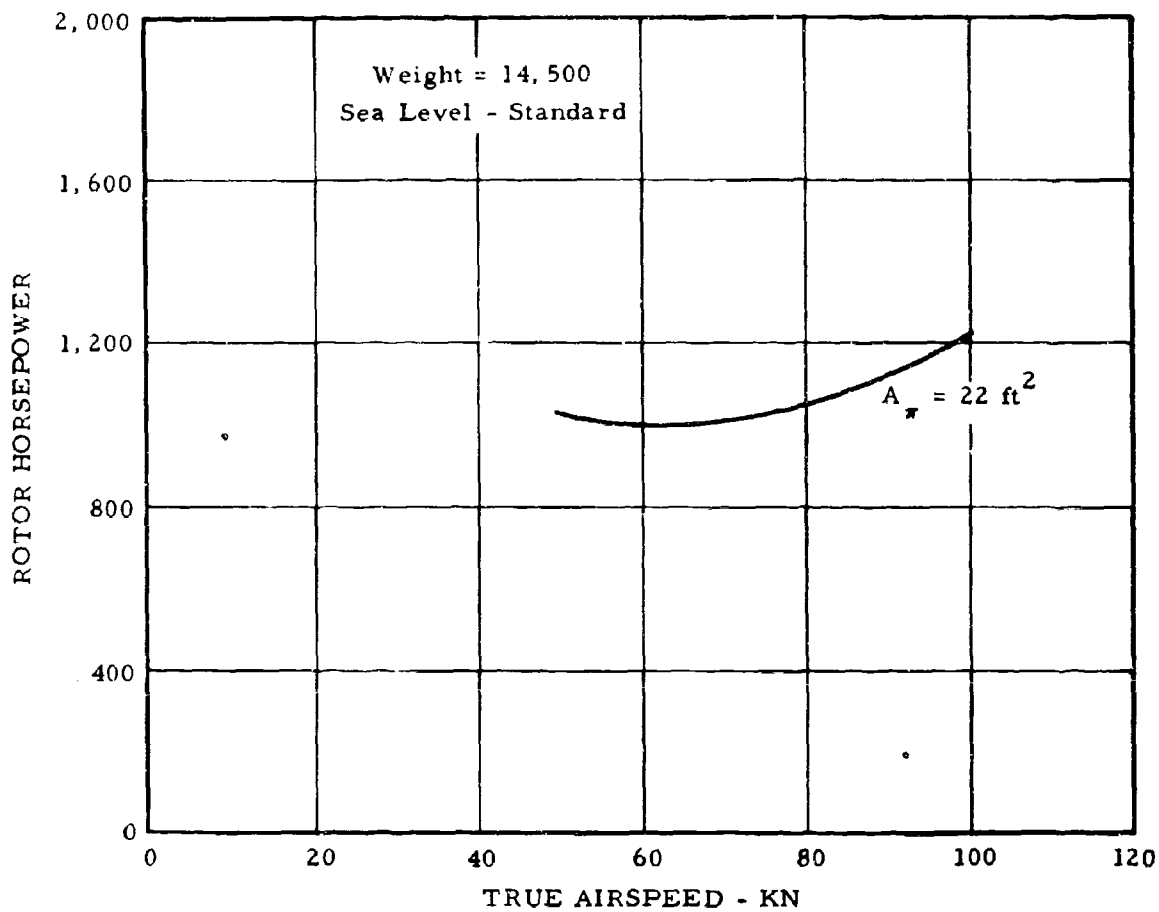
Figure 33. Predicted Power Required With Drag Cleanup  
(Weight = 14,500 Pounds, Sea Level Standard).

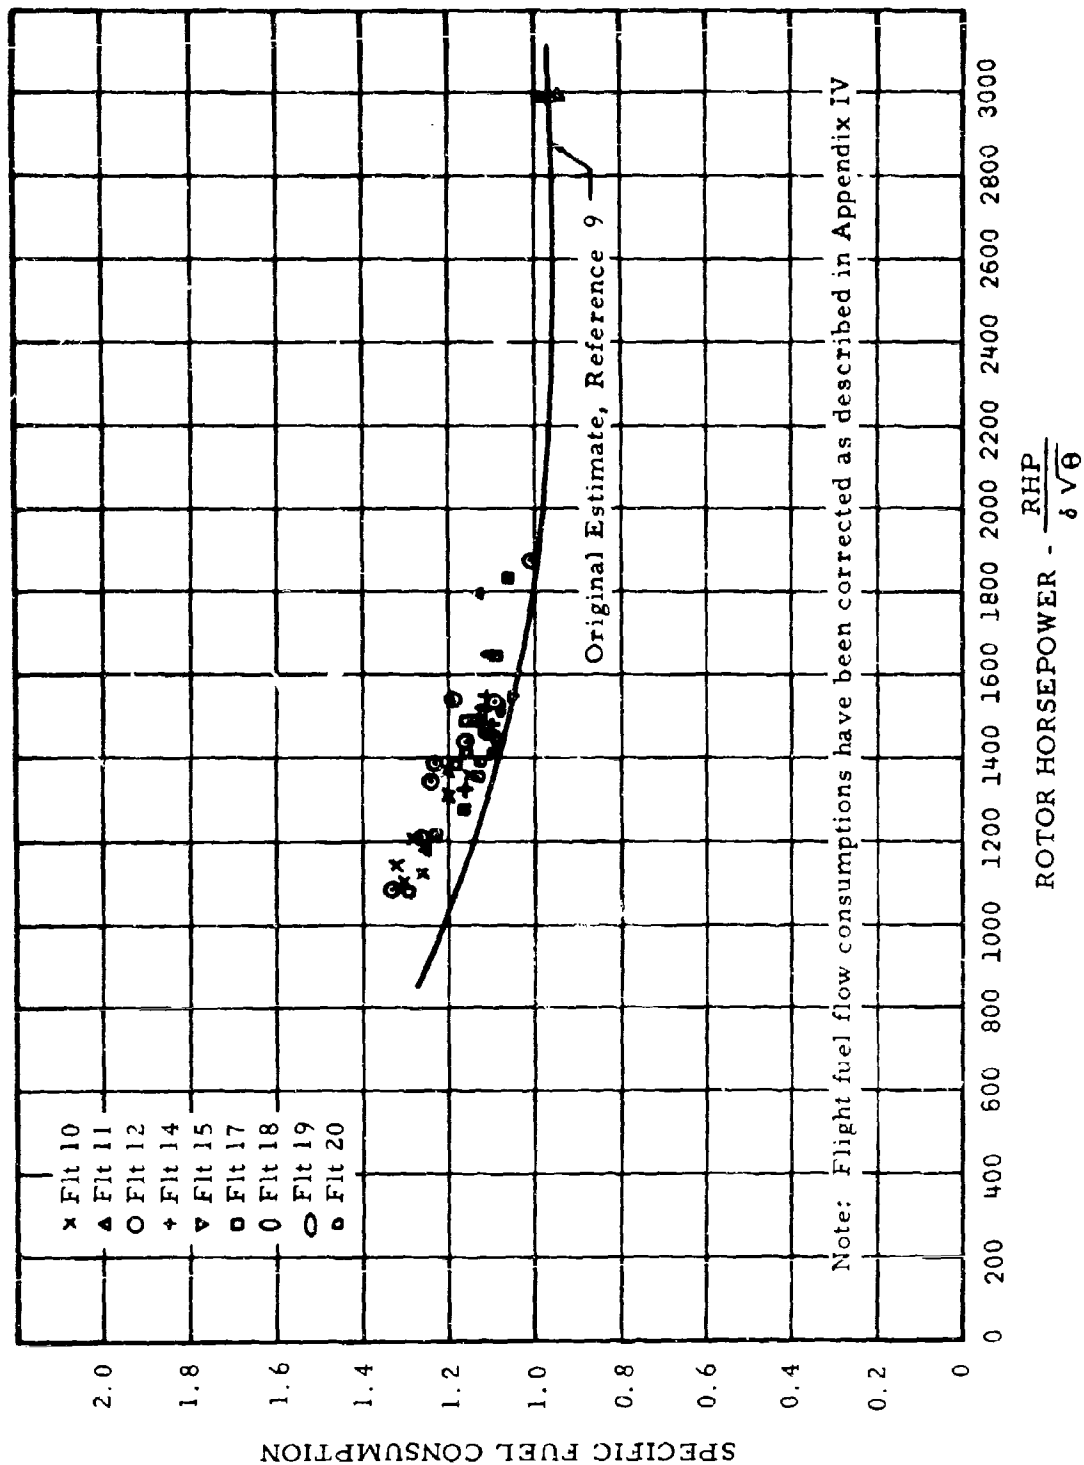
Figure 34. Tentative Specific Fuel Consumption Correlation.

A final result of the tentative power available curve is the specific fuel consumption study of Figure 34. Fuel flows used here have been corrected in accordance with the discussion given in Appendix IV. The flight points lie approximately 5 to 8 percent above the predicted levels, which is generally consistent with the direct fuel flow versus lift correlation of Figure 19. This agreement cannot be construed as adding confidence to the fuel flow levels, since the same values are used in each figure, but it does suggest that

the external aerodynamic assumptions relating rotor power to lift are consistent on an overall basis. The general level of specific fuel consumption deduced in Figure 34 must be taken as highly encouraging, since there are many known areas for future improvement in blade aerodynamic cleanness.

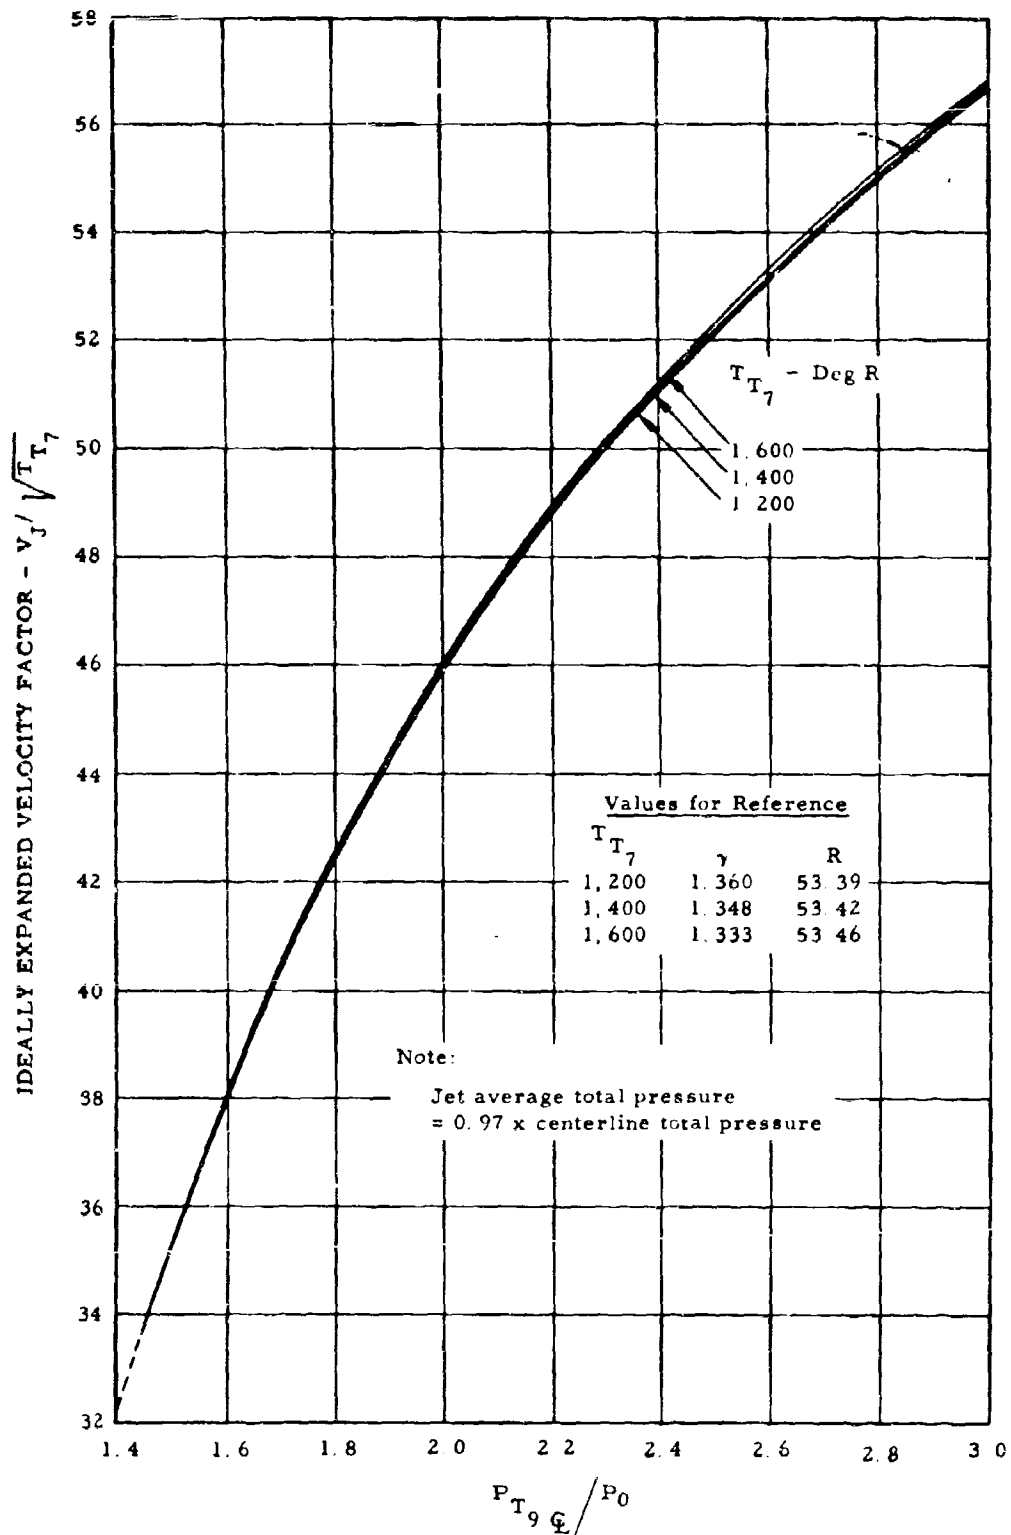
Figure 35. Hot Cycle Rotor Jet Velocity.
